**PROSPECT  
PROPERTIES**  
**Home Inspections**

**Inspection Report For:**  
**John and Jane Doe**

**Property Inspected:**  
**4110 Prospect Lane**  
**Richmond, VA 23233**

**Date Inspected: February 10, 2009**

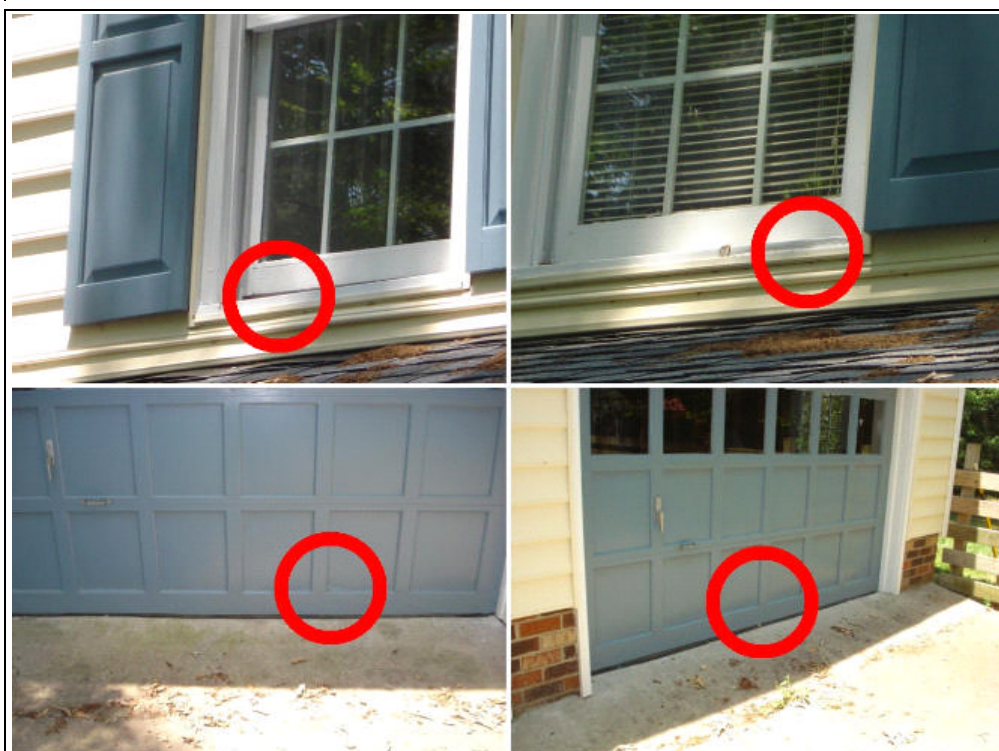
Moisture damage observed at the following areas: sills on two of the front second floor windows above the porch, the bottom center window sash above the front porch, the sill and brickmoldings on the right side second floor bedroom window and both bottom panels on the garage doors. **Estimated cost to replace and paint damaged trim and garage door panels, \$1,400 - 1,550.**

Moisture damage observed at the following areas: sills on two of the front second floor windows above the porch, the bottom center window sash above the front porch, the sill and brickmoldings on the right side second floor bedroom window and both bottom panels on the garage doors. Recommend caulking/sealing walls at pipe penetrations.

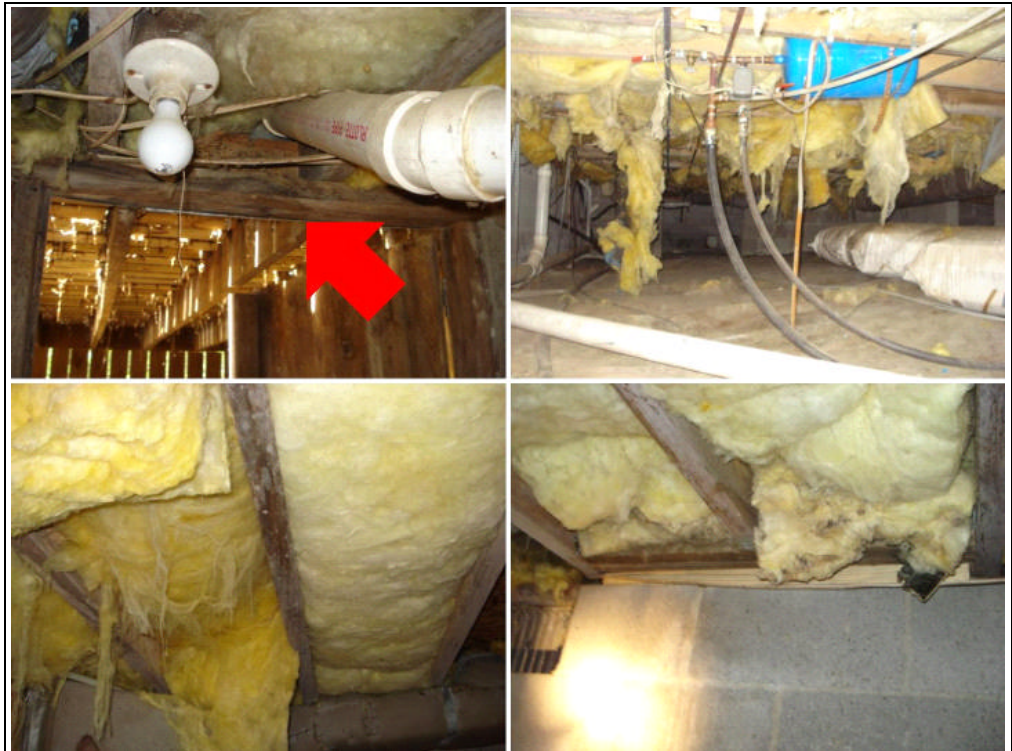
Mold and mildew is visible on framing in crawl. The insulation throughout the crawl is in poor condition and should be removed so that the floor joists can be cleaned and treated with "Timbor" or like fungicide product. New insulation and a vapor barrier should be installed after treating and cleaning of mildew and mold is completed. **\$2,100 - 2,350.** The sill over the crawl door is sagging. A header needs to be installed to support the sill and floor joists. **\$250 - 300.**

Mold and mildew is visible on framing in crawl. The insulation throughout the crawl is in poor condition and should be removed so that the floor joists can be cleaned and treated with "Timbor" or like fungicide product. New insulation and a vapor barrier should be installed after treating and cleaning of mildew and mold is completed. The sill over the crawl door is sagging. A header needs to be installed to support the sill and floor joists. One of the floor joists under the back door has been repaired. One of the floor joists near the crawl door opening has settled due to past moisture damage.

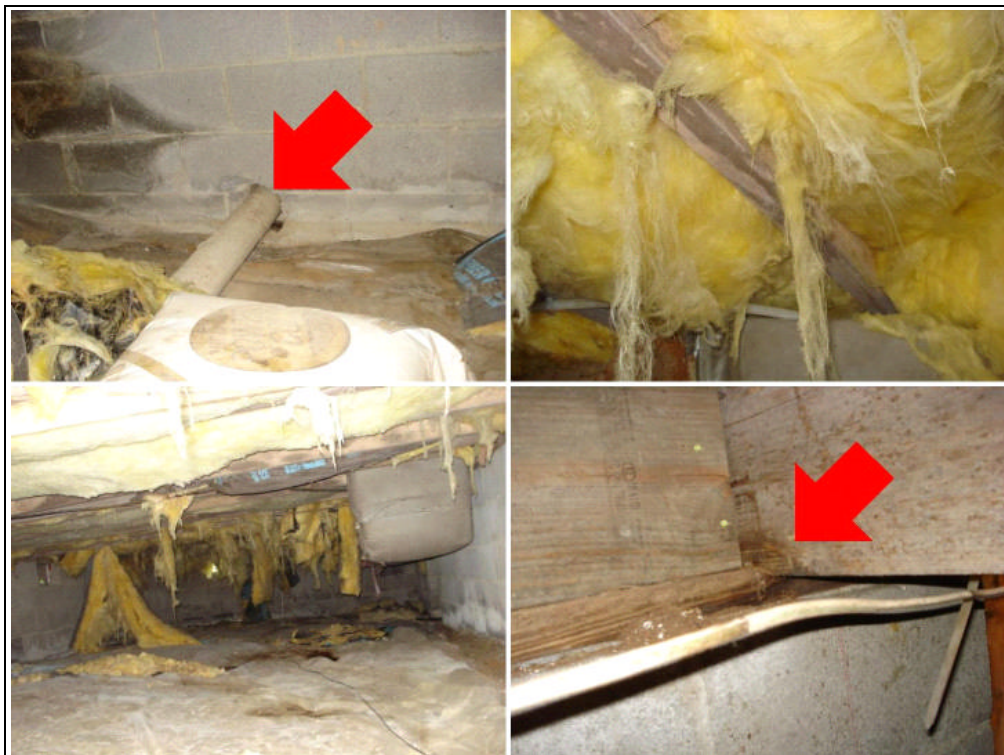
CRAWL SPACE REPAIRS:

Additional pictures.

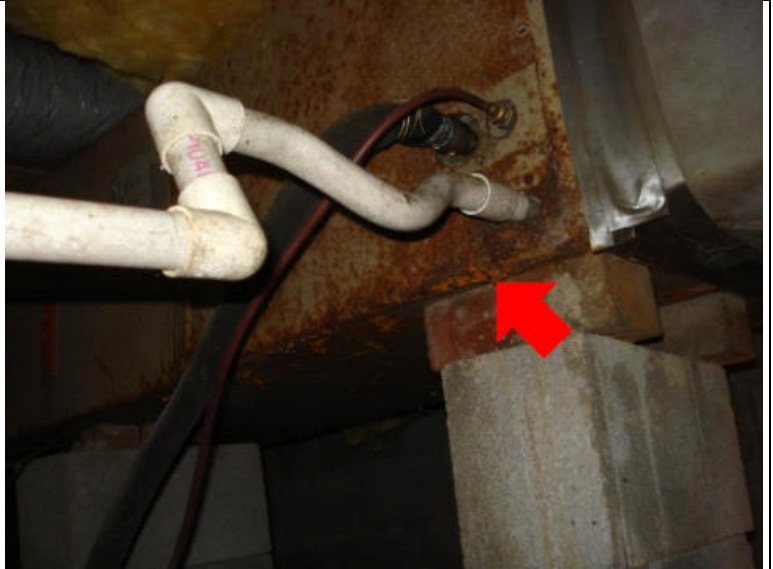
Corrosion is noted.

System is at or near the end of its useful life; due to age and general wear that has occurred over the years.

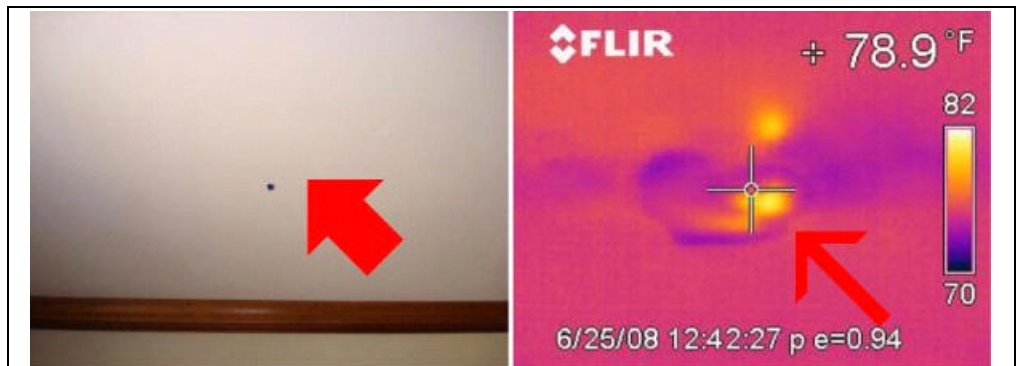
Ceilings were scanned with an infrared camera and moisture was observed and detected with a moisture meter in the ceiling under the master bathroom. The brighter yellow spots represent hot water dripping onto the ceiling. **Recommend having plumber evaluate and determine source of moisture/leak.**

Drywall, Typical cracks and evidence of patching is noted. Ceilings were scanned with an infrared camera and moisture was observed and detected with a moisture meter in the ceiling under the master bathroom. The bright yellow spots is evidence of hot water dripping on the ceiling. Fresh paint may obscure past defects.

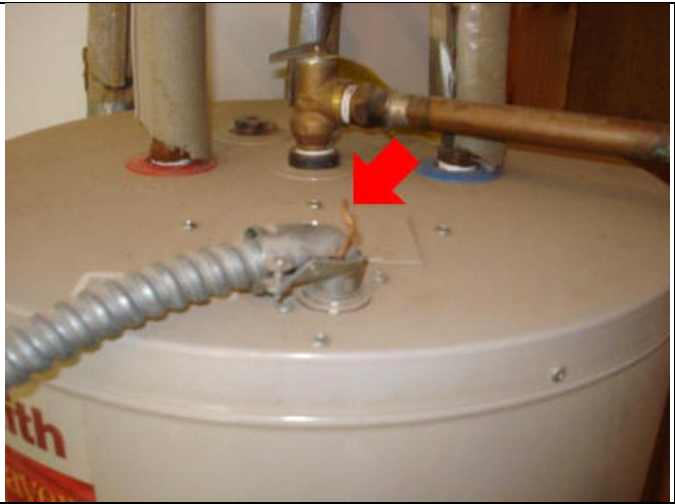
The ground wire is not properly connected. **\$65 - 95.**

CONDITION:  
The ground wire is not properly connected. Unit is at or near the end of its useful life; due to age and general wear that has occurred over the years.
